Investigative Report – Structural Issues

2726 W. Cortez Street Water Intrusion

ESi Project No: 60191A

Client File No: A00000529765

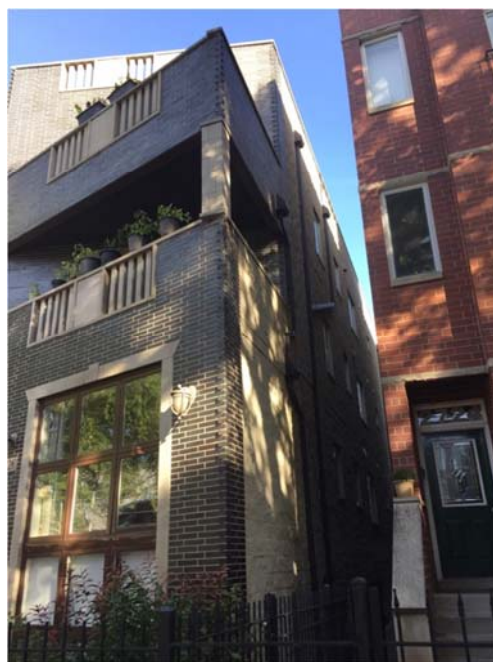
ESI made a site inspection to the structure on October 19, 2017. The subject structure was a three-story condominium with a masonry exterior and a flat roof. Figure 1 provides a satellite view of the structure taken from Google Maps. Figure 2 provides an elevation view of the front of the structure taken at the time of the site inspection. It is estimated that the structure was constructed between 10 and 15 years ago.

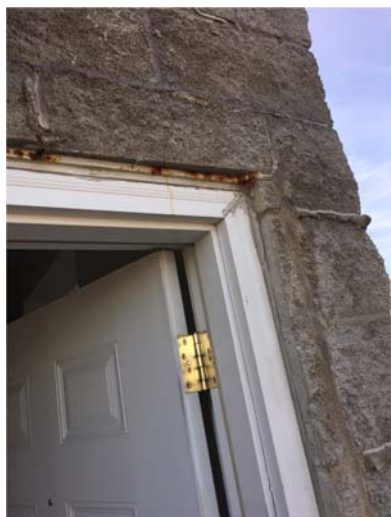
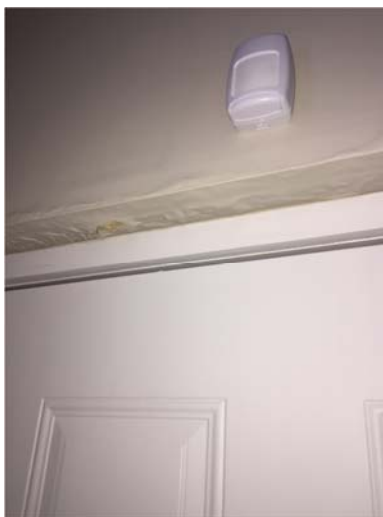
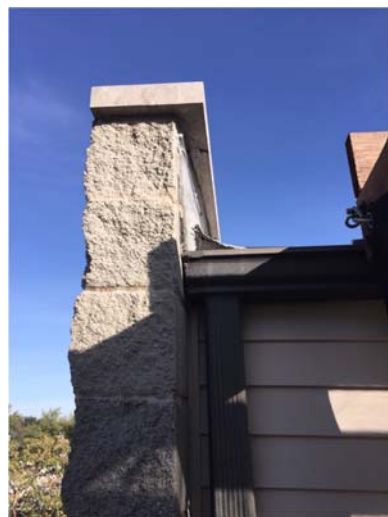
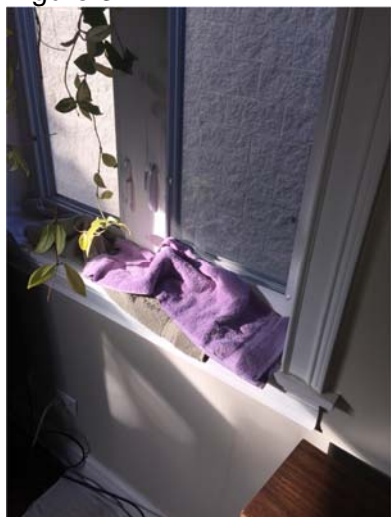
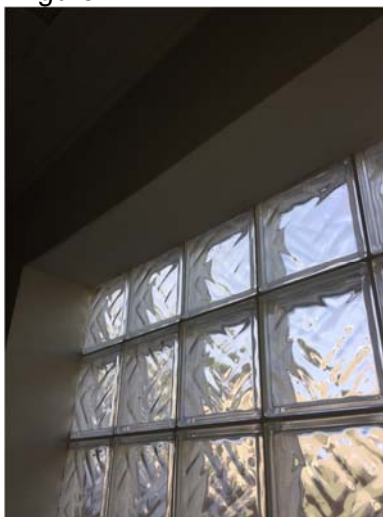
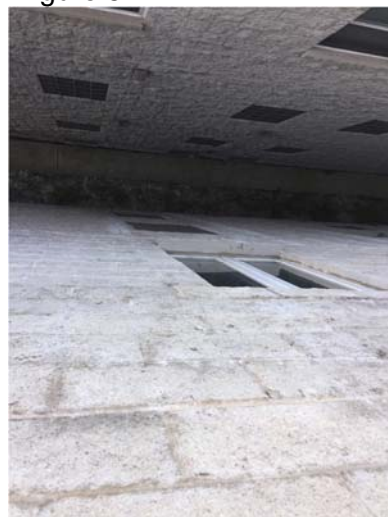
ESI inspected the condition of the structure at the time of the site inspection. The following is a summary of some of ESI's observations (Figures 3 through 8):

- Water staining was evident at openings in the masonry including windows on the west face of the building and the rear entryway.
- There was no evidence of any flashing protruding from the walls at the location of the wall openings where water infiltration was occurring.
- There was no evidence of issues with the roofing membrane.

- Water infiltration is occurring at various locations of the structure, but particularly at window and door openings.
- The water infiltration is occurring because of deficiencies in the original construction of the building with the predominate issue being improper flashing at wall openings.

- This condition was not of recent origin and has been present since the building was constructed.
- ESI recommends that the owner retain a masonry contractor to make exploratory openings in the masonry where the water infiltration is occurring and install proper flashing. All cracks in the masonry and other deficiencies should be addressed at that time.

- The flashing detail shall be installed in a manner that allows for any infiltration water to flow out of the building and shall also contain proper end dams.
